# South CCR Surface Impoundment 2022 Annual Inspection Report

## Walter Scott, Jr. Energy Center

# **MidAmerican Energy Company Walter Scott, Jr. Energy Center South CCR Surface Impoundment 2022 Annual Inspection Report**

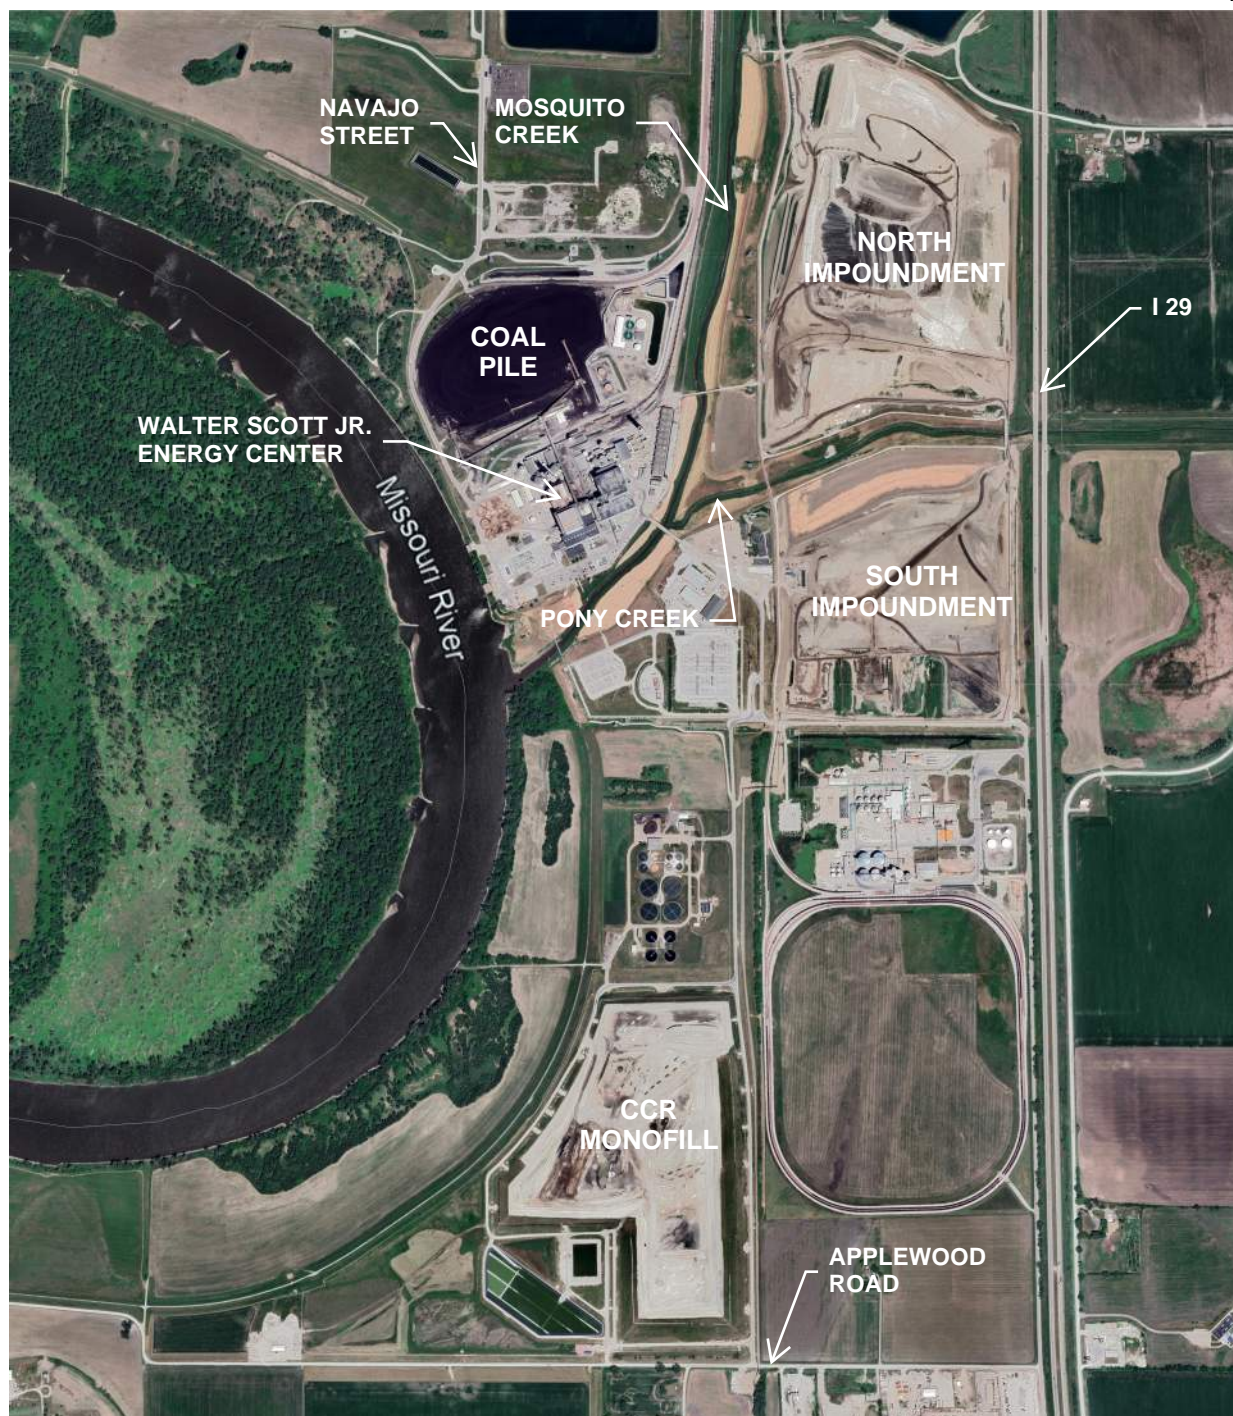
**Appendix A**  
**Facility Site Map**

**NOTE:** AERIAL IMAGE PROVIDED BY GOOGLE EARTH.

The South Impoundment is located on the southeast side of the WSEC plant site along the north side of the south access road, and immediately west of Interstate 29. The South Impoundment had an intake structure located at the northwest corner which recycled water to the plant. Recycled water was used to sluice bottom ash into this impoundment. A railroad line runs along the western side of the impoundment from south to north. There are two peninsulas which extend into the impoundment on the south side. They serve as a foundation for transmission lines and are not considered part of the impoundment embankment. The area enclosed by the perimeter embankment is approximately 133 acres. A facility site map showing location of South Impoundment is included in Appendix A.
