CCR Surface Impoundment 3B 2018 Annual Inspection Report

Neal North Energy Center

MidAmerican Energy Company
Neal North Energy Center
2018 CCR Surface Impoundment 3B Annual Inspection Report

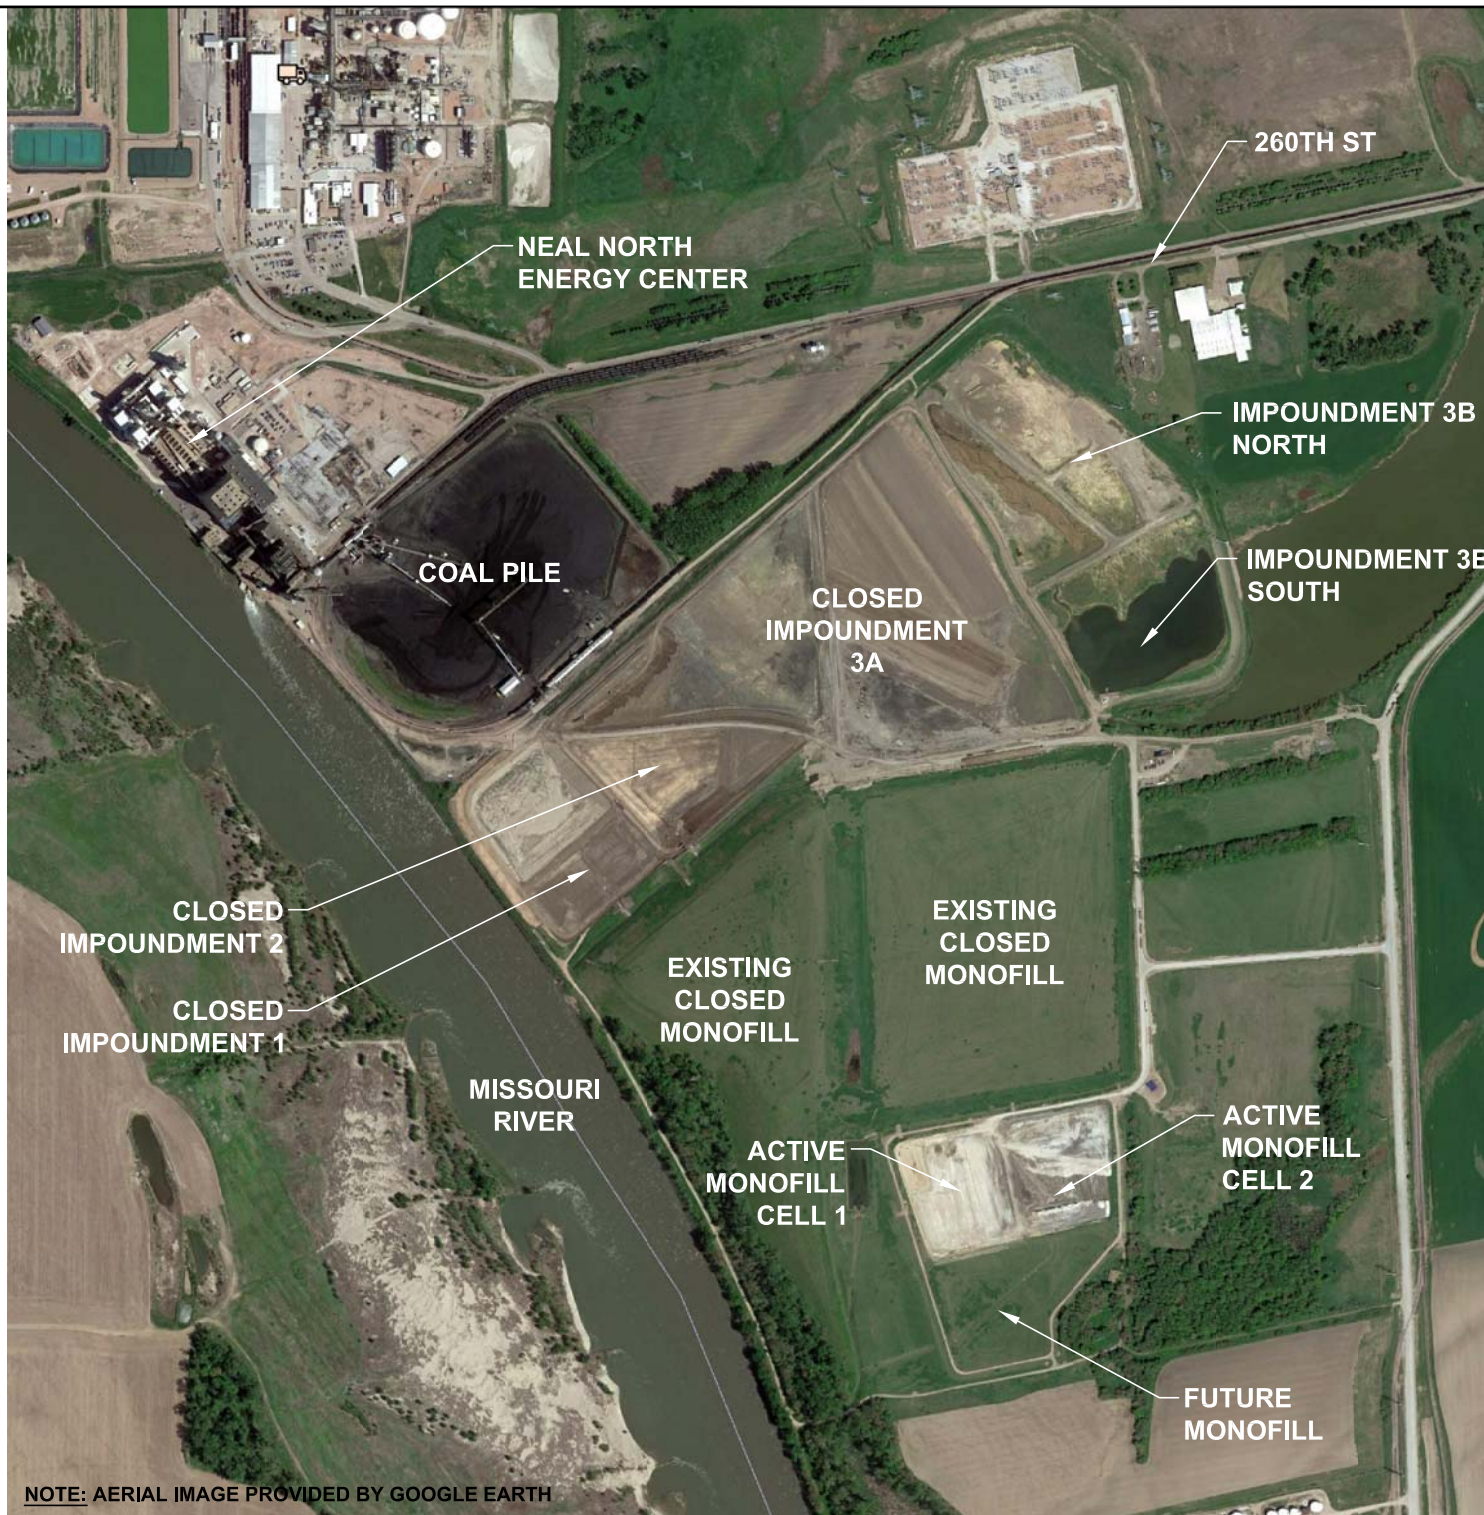
Facility Site Map

NOTE: AERIAL IMAGE PROVIDED BY GOOGLE EARTH
