West Monofill 2021 Annual Inspection Report

Louisa Generating Station

MidAmerican Energy Company Louisa Generating Station

Muscatine, Iowa January 7, 2022

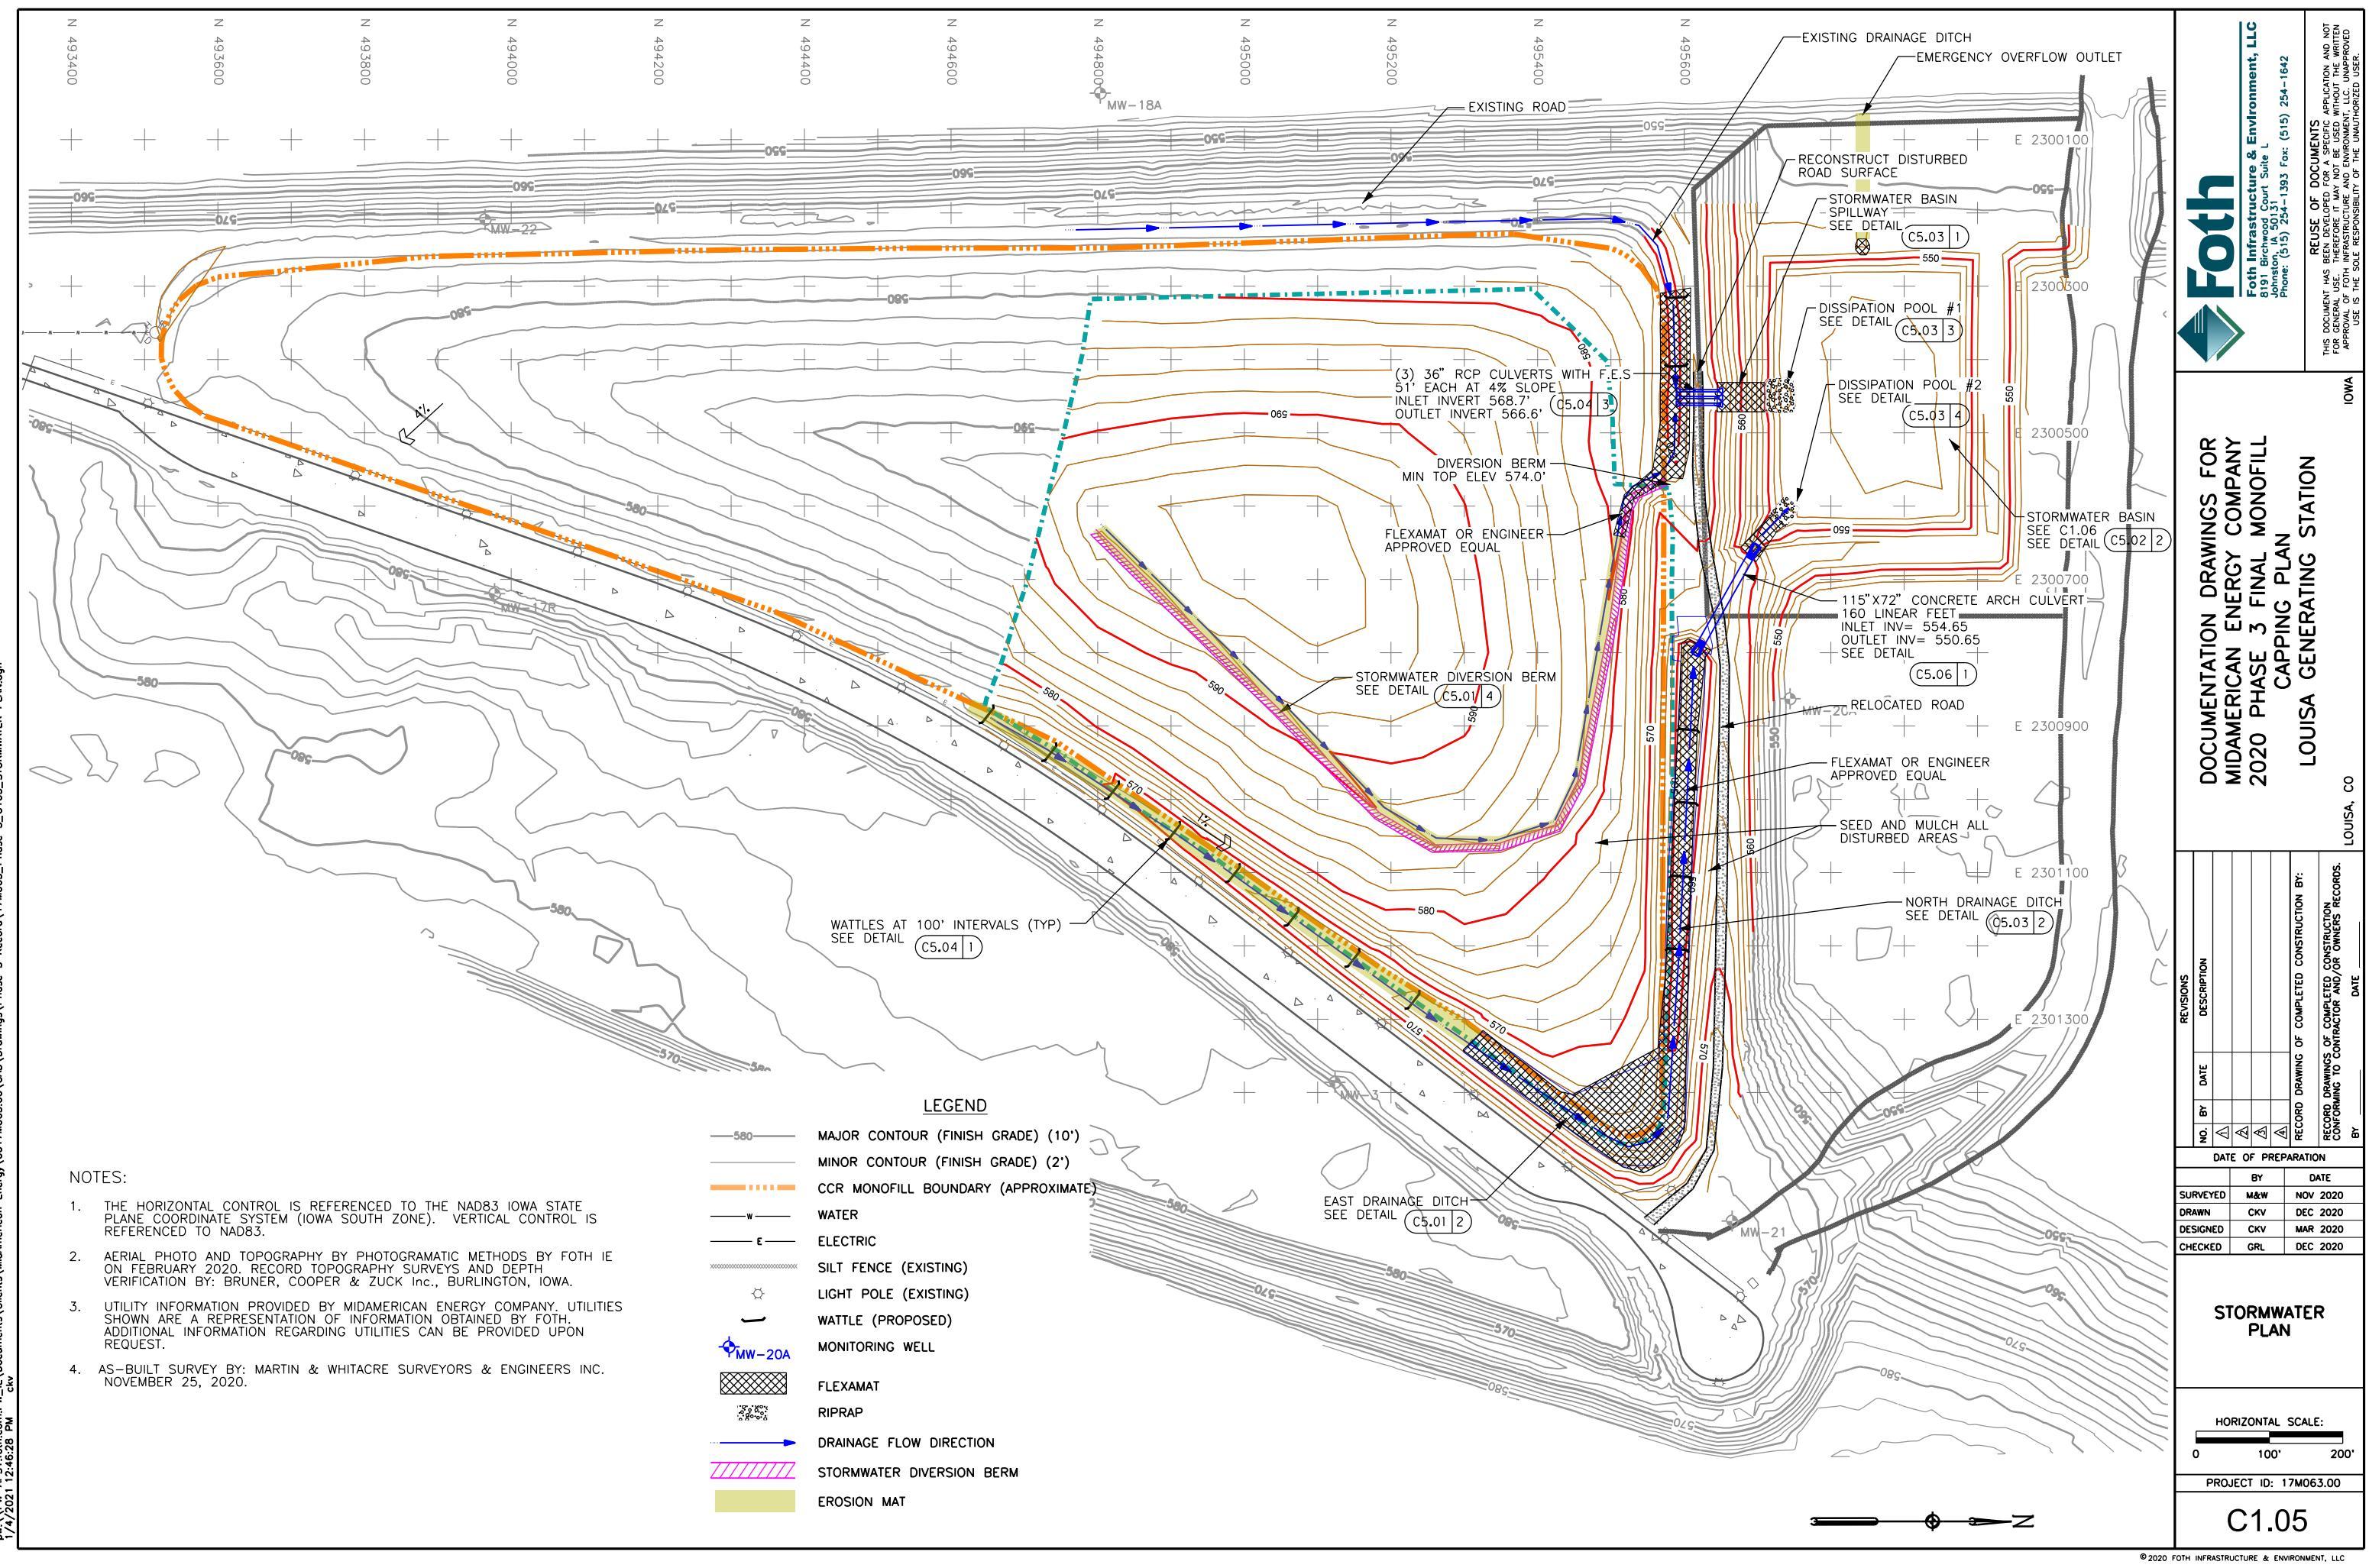
Appendix A West Monofill Final Grades and Stormwater Plan (Foth Plan excerpt of CCR website published Closure Plan)

closure grading and stormwater plan is included in Appendix A. Soil containment berms contain the CCR material along the western and northern limits of the West Monofill, while the eastern side is contained by a previously existing slope downward from the east roadway. Drainage swales and a stormwater terraces convey storm water run-off from the West Monofill toward culverts located on the north. After passing through the culverts stormwater then moves downslope to a retention basin. The exterior perimeter containment berms are vegetated on the outer slopes. Permit drawings indicate the containment berms are designed with 3.5H:1V slopes. The final grade slopes are permitted to be 4H:1V with a maximum final cover elevation of 658 feet mean sea level (MSL). During the inspection, the Monofill was observed with final cover in accordance with the Closure permit for the West Monofill under 70-SDP-17-04, issued by lowa Department of Natural Resources on September 17, 2021.
